# ENGINE DIAGNOSTICS PROGRAM CF6-50 ENGINE PERFORMANCE DETERIORATION

Ray H. Wulf

General Electric Company  
Aircraft Engine Business Group  
Evendale, Ohio 45215

November 1980

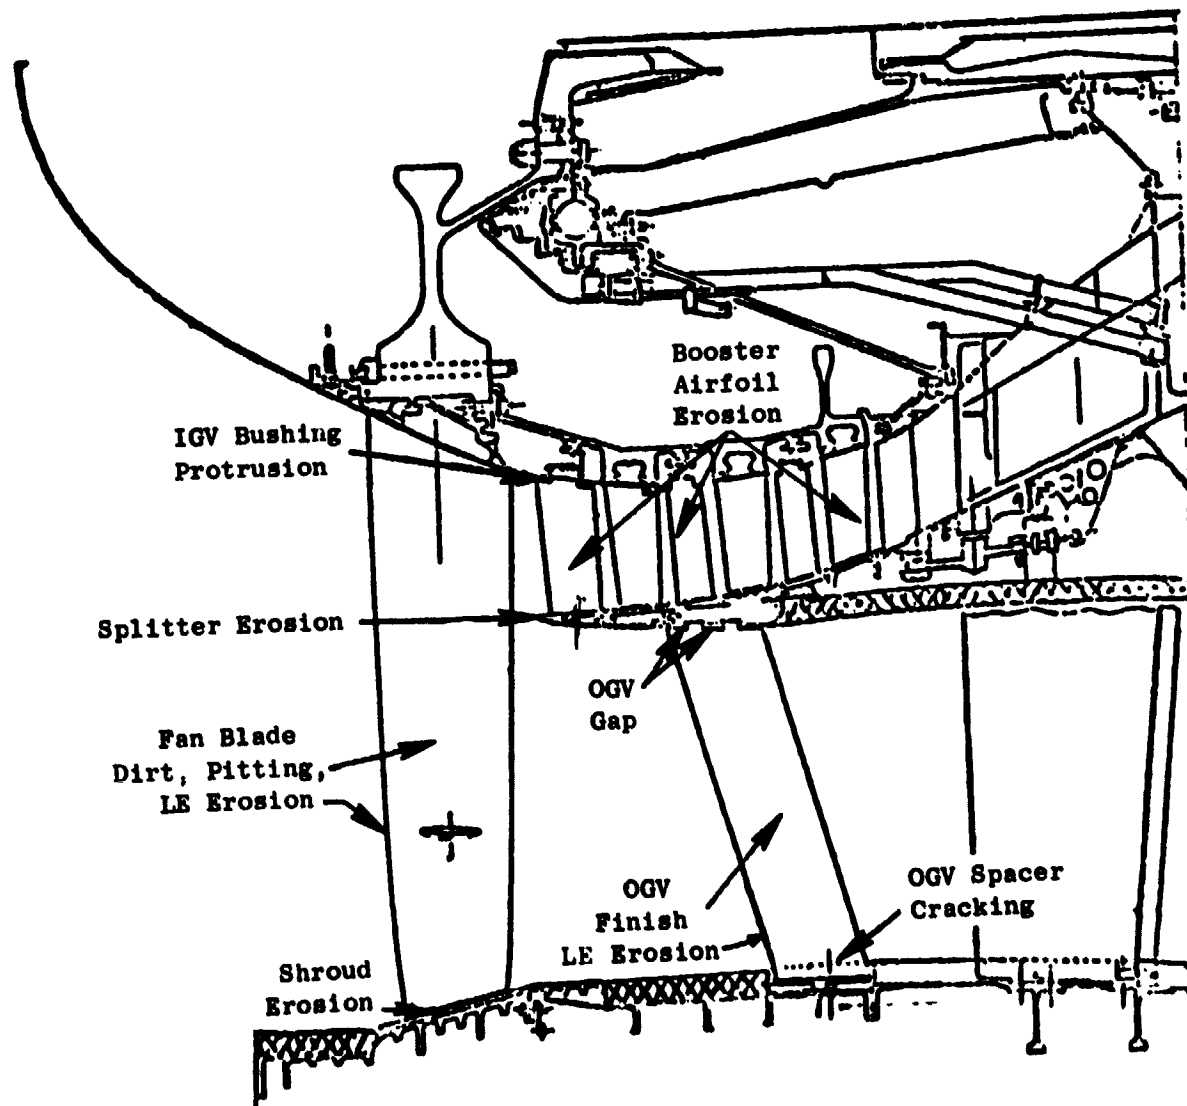
Figure 4-37. CF6-50 Deterioration Modes - Fan Section.

Fan Section - Deterioration of the fan section is generally time-dependent (rather than event-oriented) and can be categorized into two broad classifications: (1) flowpath deterioration and (2) airfoil quality degradation. Each of these two classifications will be discussed separately. The results are based on inspecting airline modules that have accumulated 10,000 to 12,000 hours since new, and which have logged 3,000 to 5,000 hours since the last shop visit. A cross section of the basic fan module is presented in Figure 4-37, which notes the pertinent areas of performance deterioration.

The sources of flowpath deterioration (Figure 4-37) include shroud erosion, outlet guide vane (OGV) spacer cracking, splitter erosion, and protrusion of inlet guide vane (IGV) inner bushings.

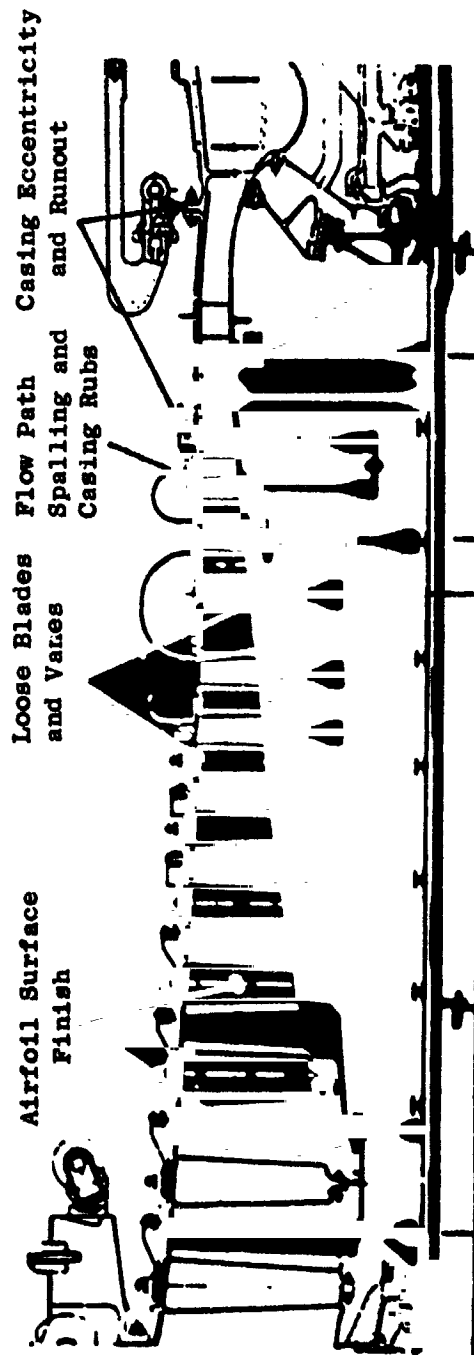
High Pressure Compressor Section - Performance deterioration of the high pressure compressor (HPC) can result from a number of factors. These factors can be generally classified as either airfoil tip clearance changes, airfoil quality degradation, or leakage. A cross section of the HPC module showing the deterioration modes is presented in Figure 4-44.

Figure 4-44. CF6-50 Deterioration Modes - HP Compressor Section.

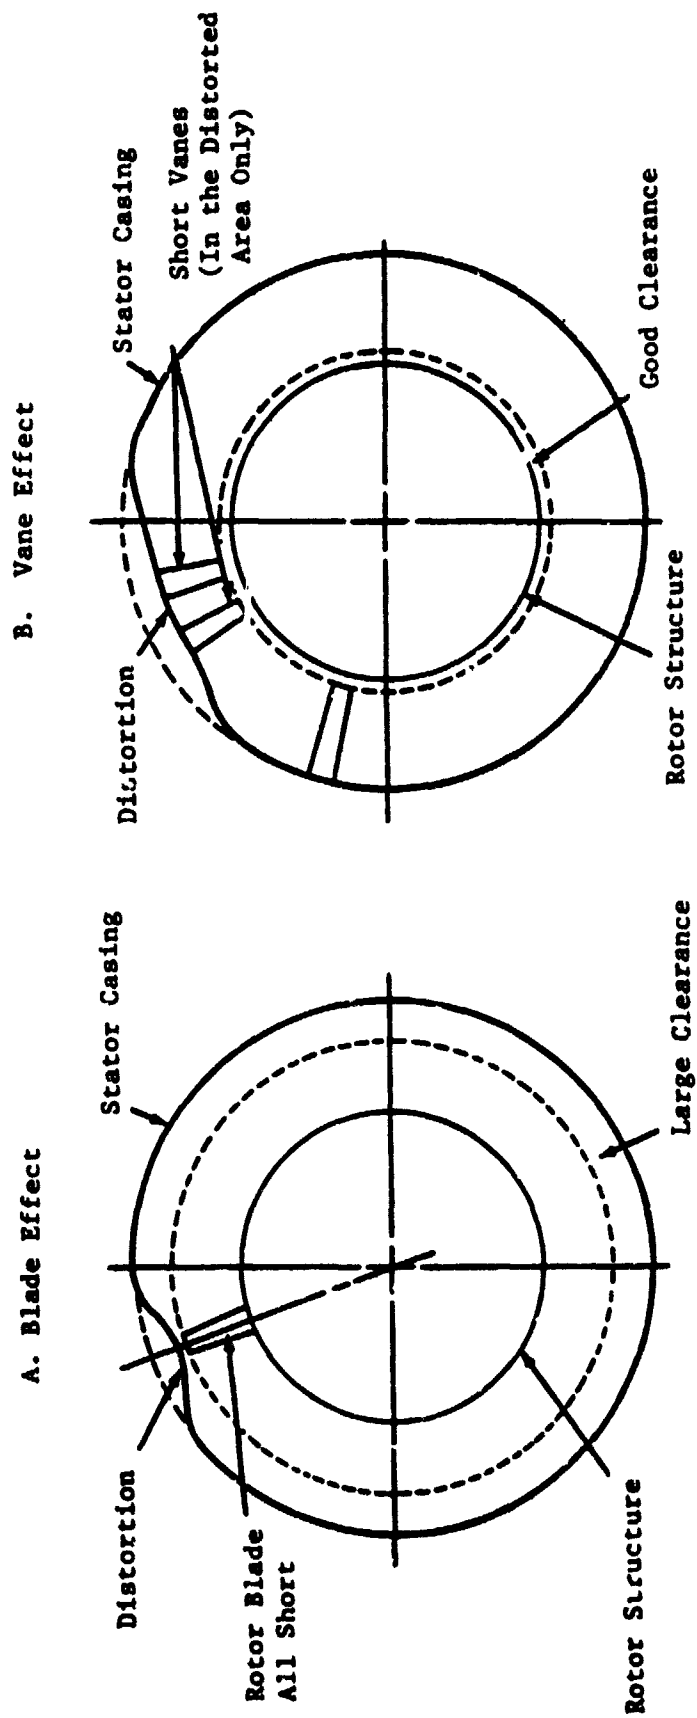
Figure 4-49. Effect of Casing Distortion.

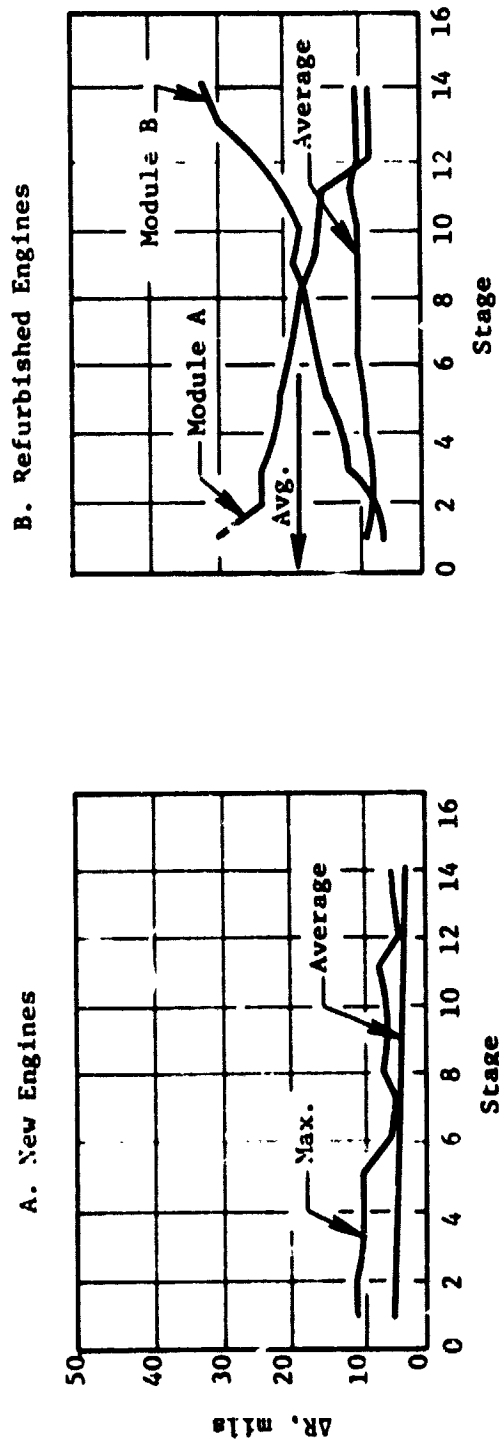
Stator casing out-of-roundness was investigated for both production new and airline service parts. The airline service parts were inspected both during the repair with the rub coat material stripped and after refurbishment. The sample size and inspection results are presented in Table 4-XV. These data show a significant out-of-roundness condition for both nonrepaired and refurbished casings compared with data obtained from factory new parts. The average of these data and maximum out-of-roundness values obtained are presented by stage in Figure 4-50.

Figure 4-50. Casing Out of Roundness.

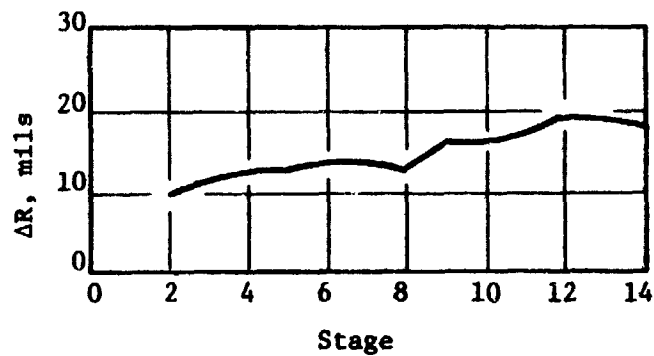
Casing Out of Roundness Versus Stage

A specific engine that failed to meet minimum performance standards after having been refurbished was disassembled and inspected. Inspection of the HP compressor which had been refurbished prior to the test cell run, indicated a large out-of-roundness condition of the casing as shown in Figure 4-52. An inspection of the rotor blade tips revealed a generally rounded condition rather than the expected square shape; a sketch showing this condition is included in Figure 4-52. This shape resulted from hand grinding during engine buildup to achieve the required minimum clearance. As noted in Figure 4-52, casing out-of-roundness was less than 0.020 inch in Stage 13, but the blades were up to 0.040 inch shorter at the leading and trailing edges. This was typical for this engine, and is a good example of how the average clearance effects from eccentric and/or out-of-round casing can be magnified. Hand grinding cannot be as closely controlled as machine grinding, and sometimes requires several "trial and error" rework cycles to produce the required minimum clearances. The procedure is also time consuming to recheck clearances and to reapply the wax strips, and the rework man tends to remove "more than enough" material the first time to avoid repeat cycles. A procedural change has been specified to require remachining rather than hand grinding if the required rework exceeds a specified level.

Figure 4-52. Types of Deterioration Modes: Casing Out of Roundness and Hand Grinding of Blade Tips.

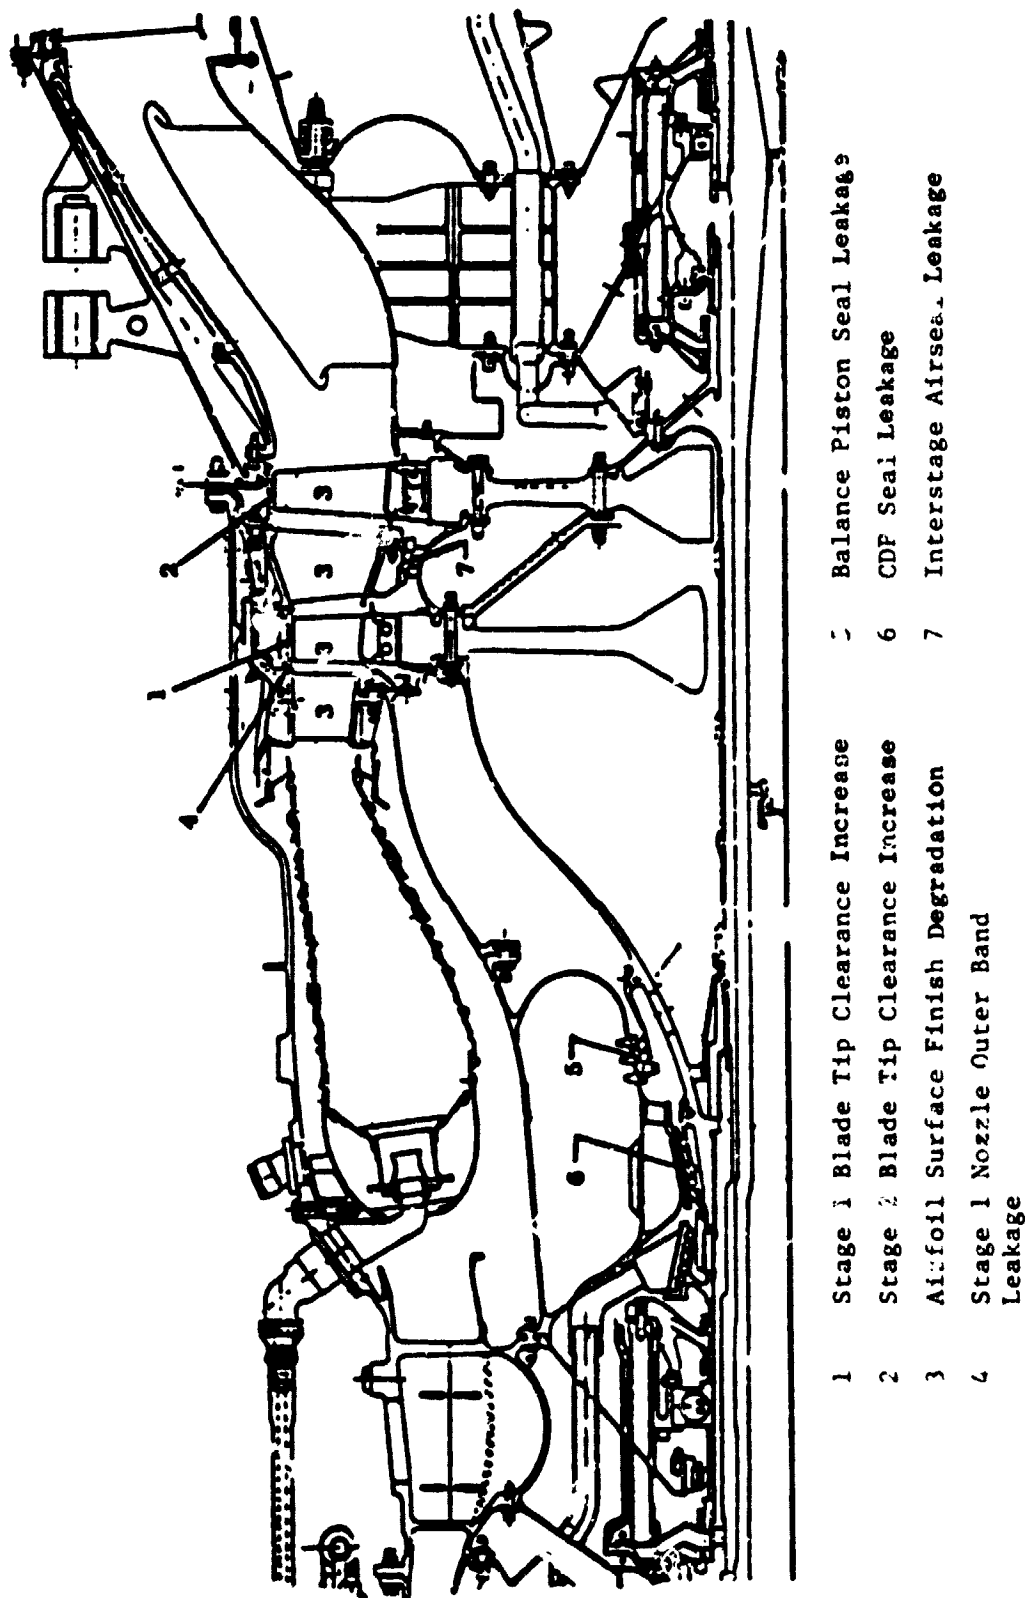
High Pressure Turbine Section - The primary causes of high pressure turbine (HPT) deterioration are changes in blade tip-to-shroud clearance, airfoil surface finish, and internal leakage (parasitics). Figure 4-61 is a schematic indicating areas of interest.

Figure 4-61. CF6-50 Deterioration Modes - HP Turbine Section.

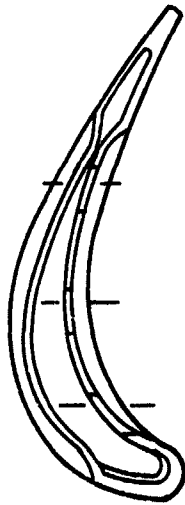
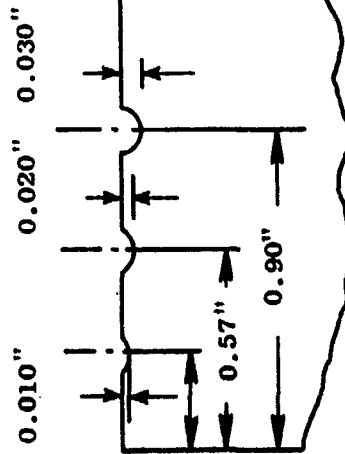
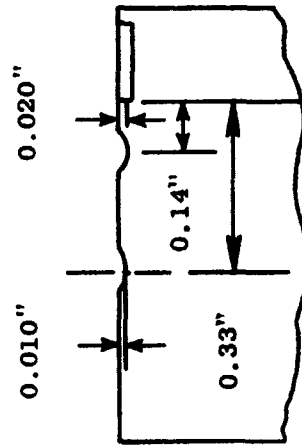
Figure 4-62. HP Turbine Blade Tip Notches (Concave Side Only).

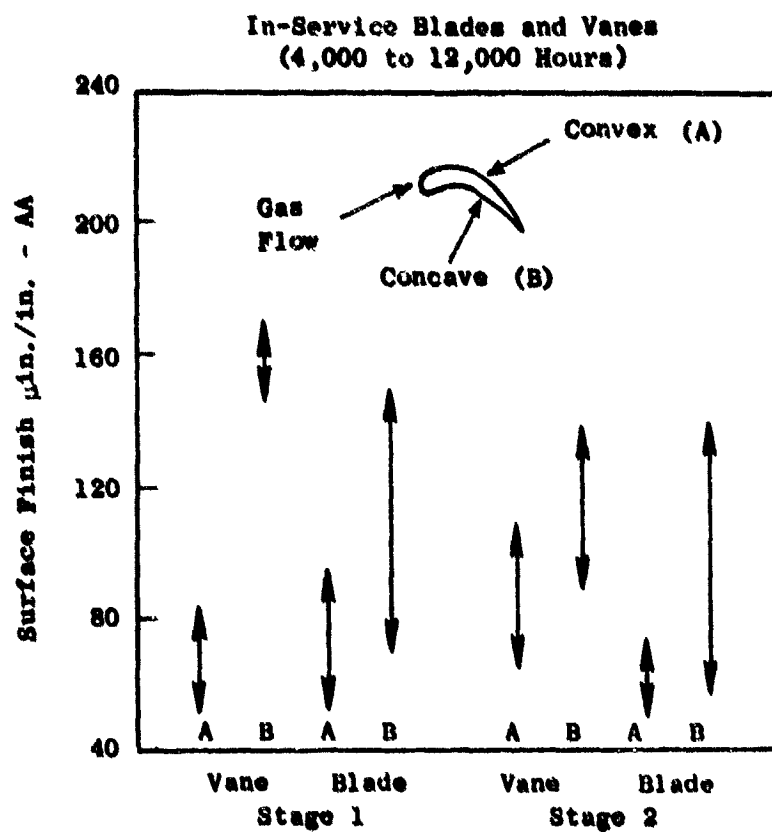
Surface finish measurements were obtained on parts with approximately 4,000 to 12,000 hours of accumulated service time. These data produced a considerable range in the surface roughness levels as shown in Figure 4-75. There was no correlation or trend of the data for surface finish with accumulated service time. The concave surface was consistently rougher; its performance effect, however, was minimal when compared with the convex surface since the same change in surface roughness produces only one-fifth the effect for the concave surface as it does for the convex (suction) side.

The Concave Surface is Consistently Rougher than the Convex Surface but has Less Effect on Turbine Efficiency.

**Figure 4-75. CF6-80 HPT Airfoil Surface Finish Range.**

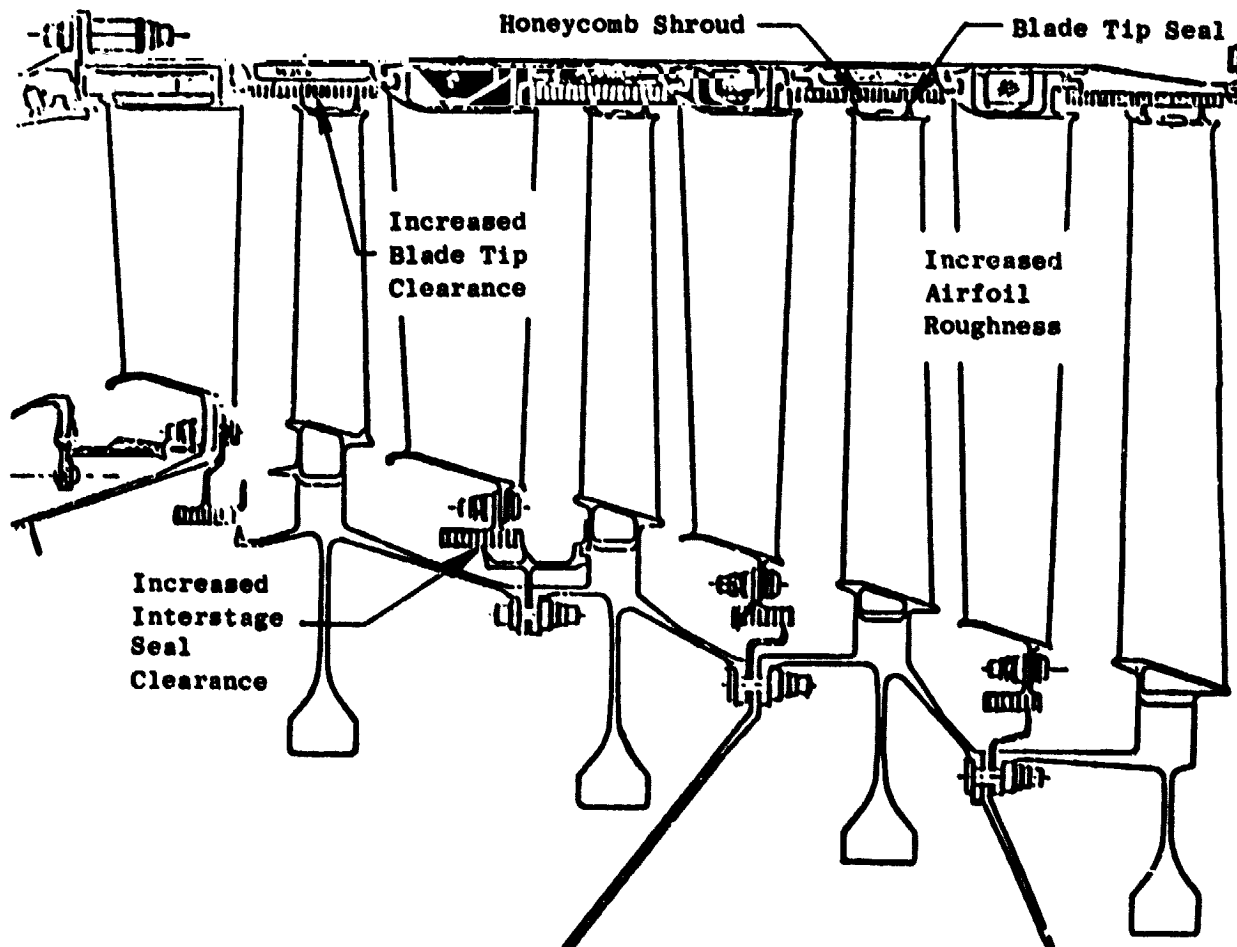
Figure 4-80. CF6-50 LP Turbine Section Deterioration Modes.

Low Pressure Turbine Section - Deterioration of low pressure turbine (LPT) components occurs primarily as a result of increased blade tip-to-shroud and interstage seal clearances, and increased airfoil surface roughness. A cross section of the LPT section is presented in Figure 4-80 showing deterioration modes.

Observations of the stationary honeycomb shrouds and interstage seals produced different results. The rotating low pressure turbine components experience axial mismatch with their static components, as much as 0.3 inch during engine operation. While this condition produces wider wear grooves in seals than experienced in other sections of the engine, analysis indicates that the minimum clearance is still controlled by the depth of the wear groove. Measurements of those grooves using soft plastic or castone impressions did not yield an acceptable reproducible record. Scale measurements at eight equally spaced circumferential locations indicated the average wear depth was 0.065 inch. This represents an average of 35 mils increase in the steady state cruise clearance when compared with similar data obtained from production new engines after their acceptance runs. Similarly, average wear depths in the stationary interstage seal were 0.070 inch which is a 40-mil increase in steady state cruise clearance over the production acceptance level.

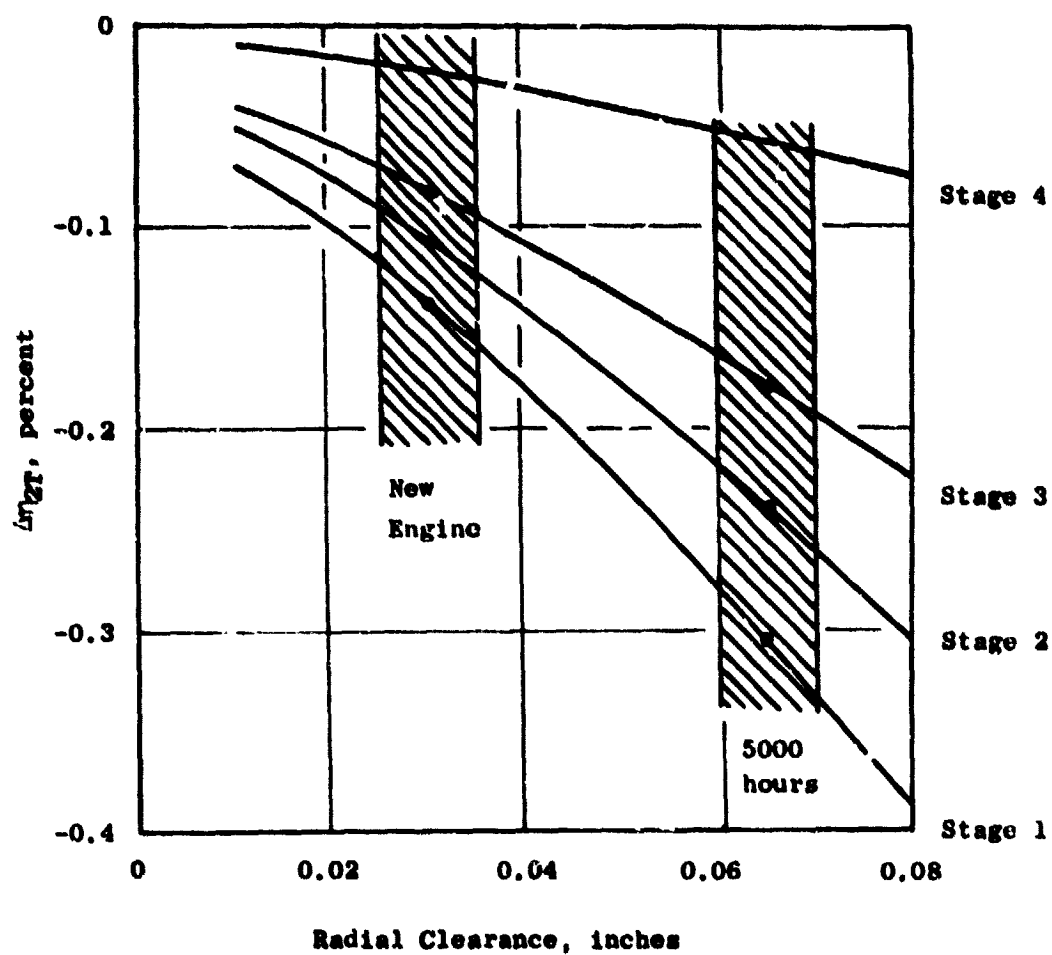
Figure 4-81. Effects of LPT Blade Tip/Shroud Clearance on Efficiency at Cruise.

The calculated performance effects from these rubs are shown in Figures 4-81 and 4-82. The estimated increase of 0.033 inch in blade tip/shroud clearance is equivalent to a 0.43 percent loss in LPT efficiency while the 0.040-inch increase in interstage seal clearance is equivalent to a 0.32 percent loss in LPT efficiency for the typical parts with 5,000 hours. This 0.75 percent loss in LPT efficiency results in a 0.52 percent increase in cruise fuel burn which is equivalent to 0.41 percent after 4,000 hours.

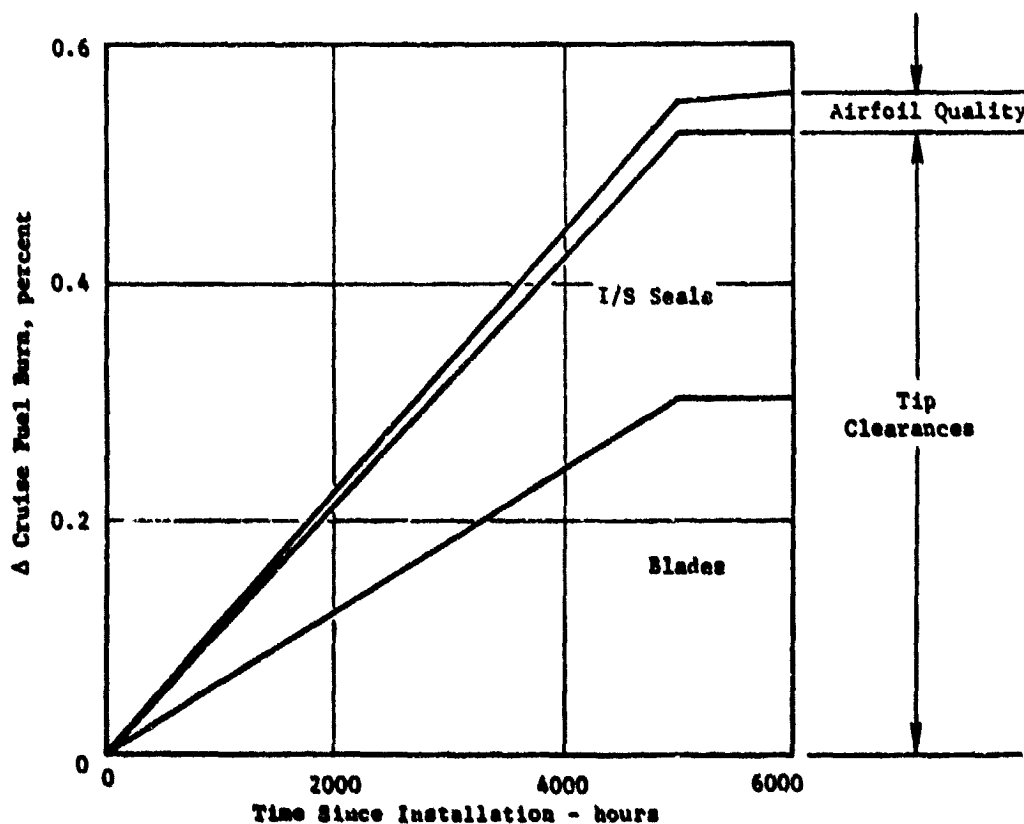
Figure 4-87. LPT Section - Estimated Deterioration Characteristics at 6000 Hours.

The deterioration modes and magnitude of loss assessed from inspection of low pressure turbine parts is presented in Table 4-XVIII. The dominant deterioration mode is increased clearances between the blade tips and tip static shrouds and between the rotating and stationary interstage seals. It was shown that, unlike the high pressure turbine rubs which result in shorter airfoils, these rubs produce large grooves in the stationary shrouds and seals which produce the increases in running clearances.

The best estimate for the rate of loss for each damage mechanism which contributes to low pressure turbine deterioration is presented in Figure 4-87. It was estimated that blade tip and interstage seal rubs occur by 5,000 hours and that airfoil surface finish continues to degrade through 6,000 total hours.

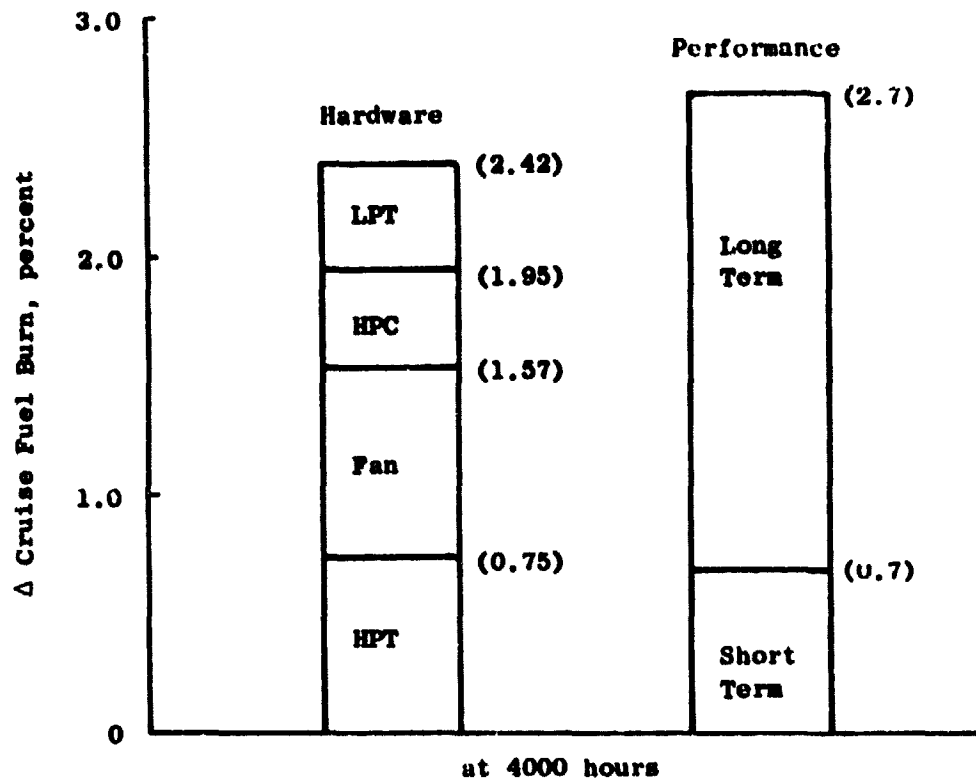
Figure 4-88. Initial Installation Engine at 4000 Hours.

A comparison of the cruise performance and hardware inspection results for the initial installation engine is presented in Figure 4-88. As shown, the comparison produced good agreement.

The comparative values of 2.42 percent in cruise fuel burn based on hardware inspection results, and 2.7 percent based on cruise performance results as shown in Figure 4-88 indicate these data are reasonable and, therefore, the hardware results were considered representative for the initial installation engine.

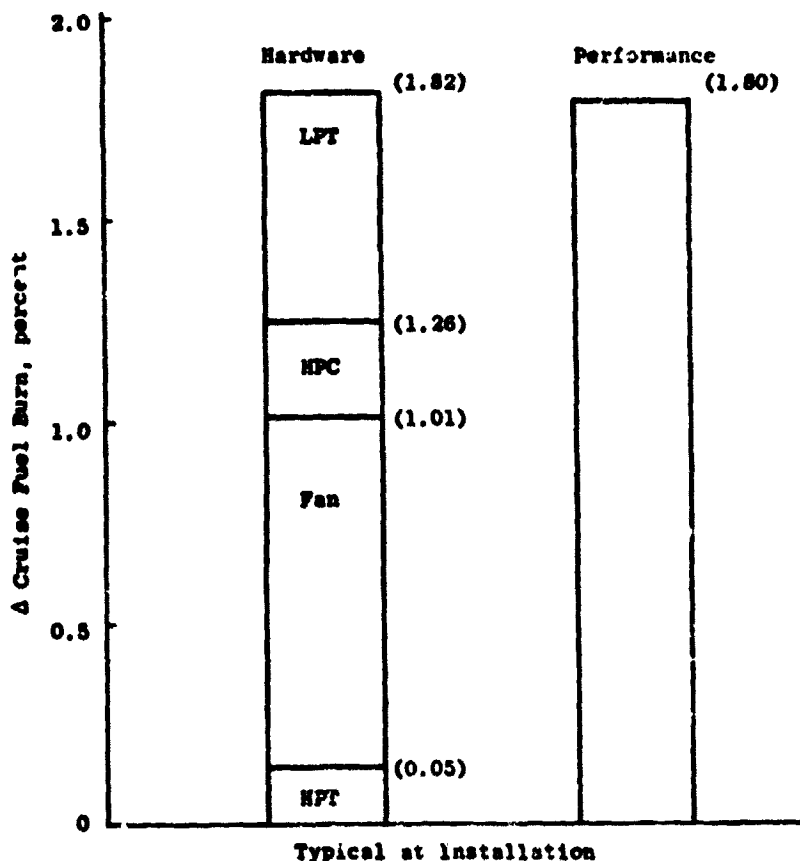
Figure 4-89. Unrestored Losses for Typical Engine.

The performance losses documented for the refurbished engine based on hardware inspection results noted in Section 4.0 were compared with the average test cell calibration run for the refurbished engine. These data are presented in Figure 4-89.

The good agreement between the fuel burn losses assessed from hardware inspection results for the refurbished engine and the corresponding performance levels measured during the engine recalibration in the test cell as shown in Figure 4-89 indicate that the hardware inspection data documenting the unrestored losses are realistic.

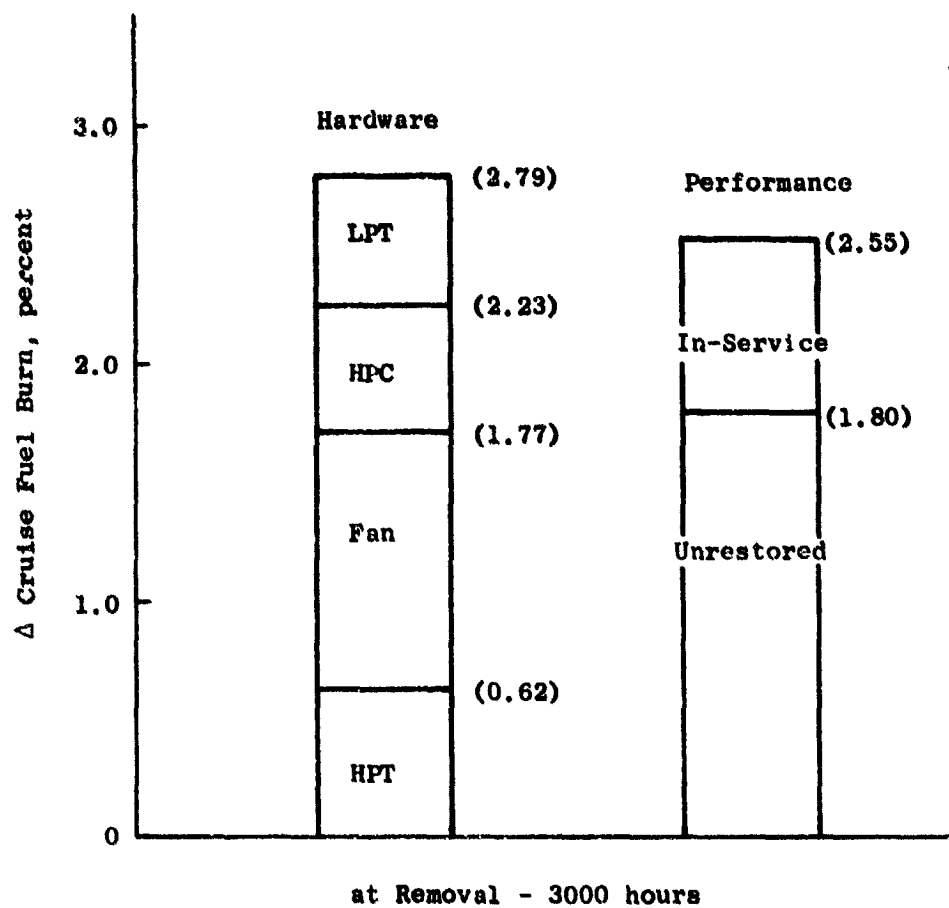
Figure 4-90. Multiple Build Engine at Removal.

The comparison of the performance deterioration assessed from measured performance data with that assessed from the hardware inspection results for the average multiple-build engine after 3,000 hours of operation is presented in Figure 4-90. This good agreement indicates the assumptions were realistic, and the data presented for the multiple-build engines are reasonable representations for the fleet. These data also tend to verify that the other comparisons are valid, since the construction of the multiple-build model is heavily dependent on the results presented for those models.
